# **Penn Branch Improvement Project**

## ***An Ultra Urban Stream Stabilization Project***

# The Ugly: Masonry Wall Assessment

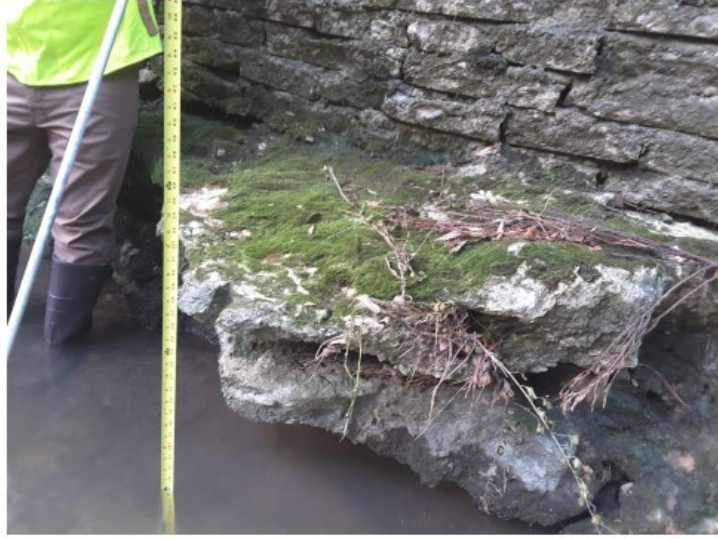
| <p>Photo No:<br/>3612A</p> <p>Location:<br/>Sta 16+75<br/>Right Wall</p> <p>Direction:<br/>Downstream</p> <p>Description:<br/>36" from top of original wall toe protection to stream bank due to stream bottom erosion downstream of culvert under Brentwood Drive.</p> | | <p>Photo No:<br/>3612B</p> <p>Location:<br/>Sta 16+75<br/>Left Wall</p> <p>Direction:<br/>Downstream</p> <p>Description:<br/>Undermining of 20 ft of wall downstream of culvert under Brentwood Drive.</p> | |
| <p>Repair Priority: 2</p> | | <p>Repair Priority: 2</p> | |

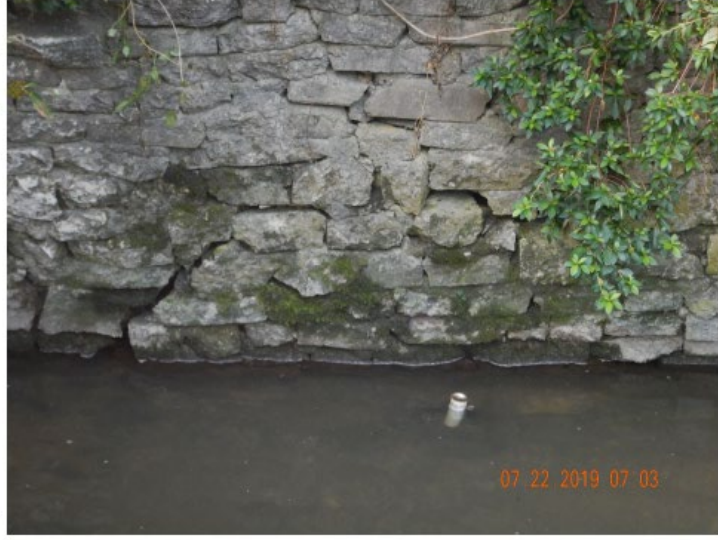
| <p>Photo No:<br/>3612H</p> <p>Location:<br/>Sta 16+75<br/>Right Wall</p> <p>Direction:<br/>Downstream</p> <p>Description:<br/>Undermining of 20 ft of wall. Large cracks full height of wall downstream of culvert under Brentwood Drive.</p> | | <p>Photo No:<br/>3612K (Defect 3613)</p> <p>Location:<br/>Sta 16+75<br/>Left Wall</p> <p>Direction:<br/>Downstream</p> <p>Description:<br/>Concrete slope protection failure. Large cracks and broken pieces in stream channel.</p> | |
| <p>Repair Priority: 2</p> | | <p>Repair Priority: 3</p> | |

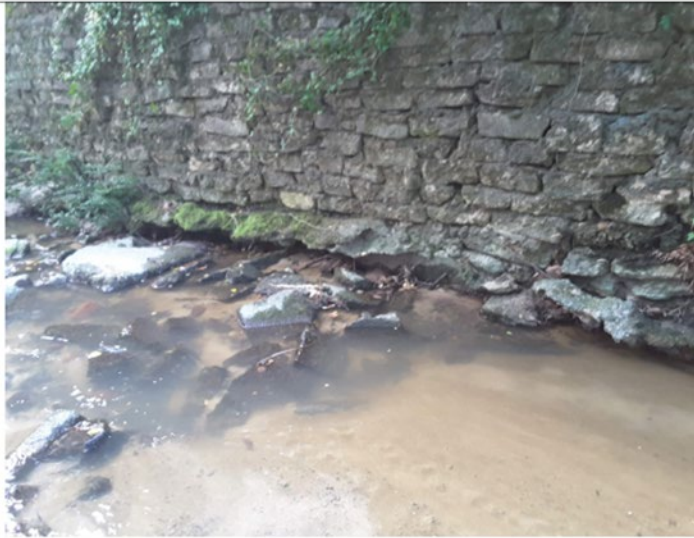
Photo No:  
4016A  
Location:  
Sta 21+60  
Right Wall  
Direction:  
Downstream  
Description:  
Continuous  
undermining from  
location 4015.

Repair Priority: 2

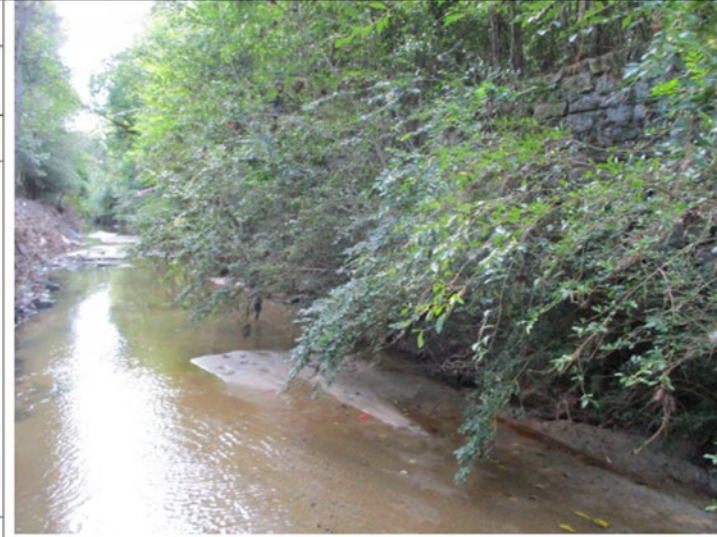
Photo No:  
4018C  
Location:  
Sta 22+50  
Right Wall  
Direction:  
Downstream  
Description:  
Overgrowth of  
vegetation in stream  
channel for 40 ft.

Repair Priority: 3

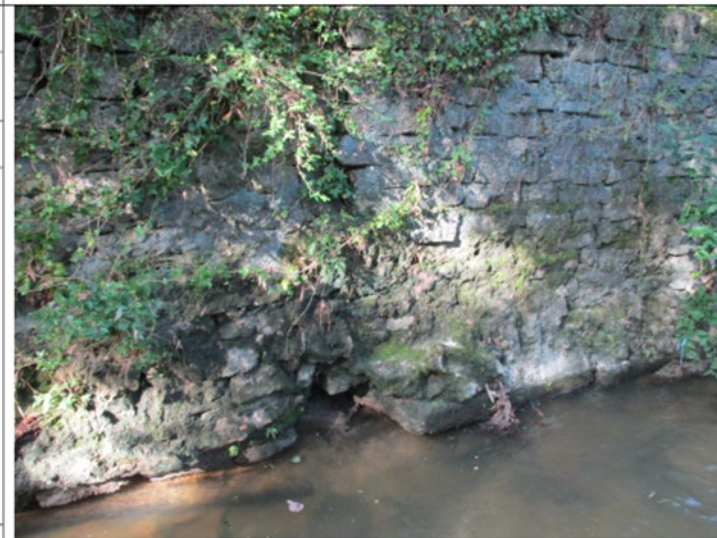
Photo No:  
4018B  
Location:  
Sta 22+50  
Right Wall  
Direction:  
Downstream  
Description:  
Large crack in wall for  
full height of wall.  
Undermining for 15 ft  
of wall.

Repair Priority: 2

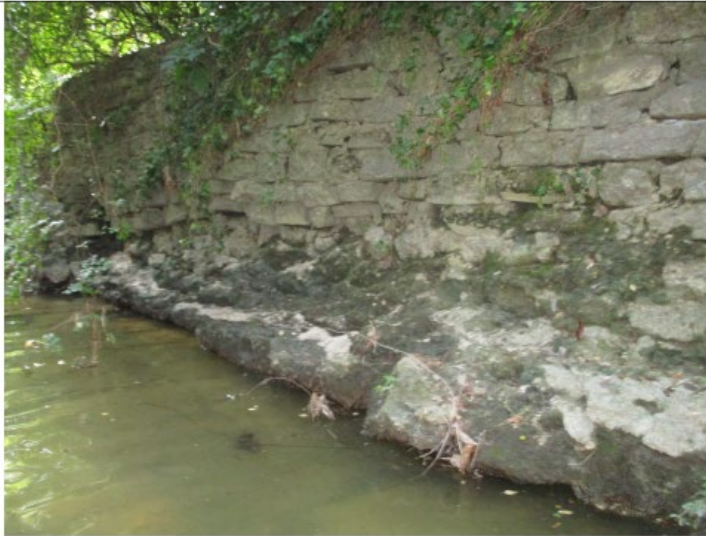
Photo No:  
4019C

Description:  
Undermining of wall  
for 25 ft.

Repair Priority: 2

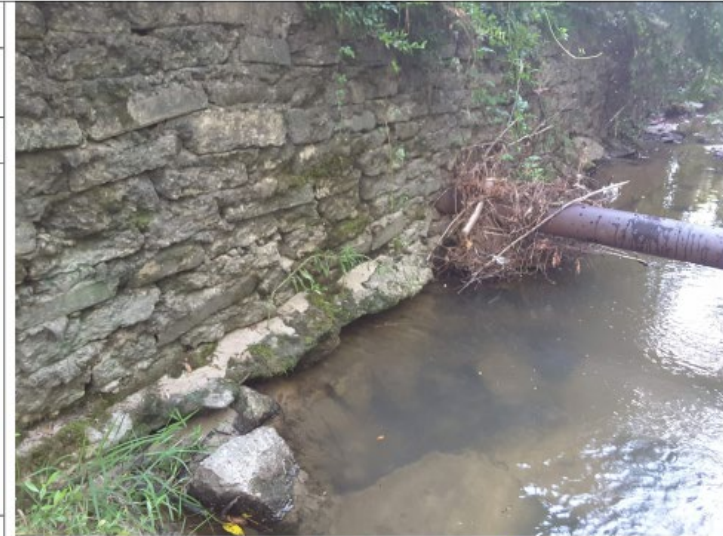
Photo No:  
4021A

Description:  
Exposed utility and  
debris build-up.  
Undermining for 10 ft  
of wall.

Repair Priority: 2

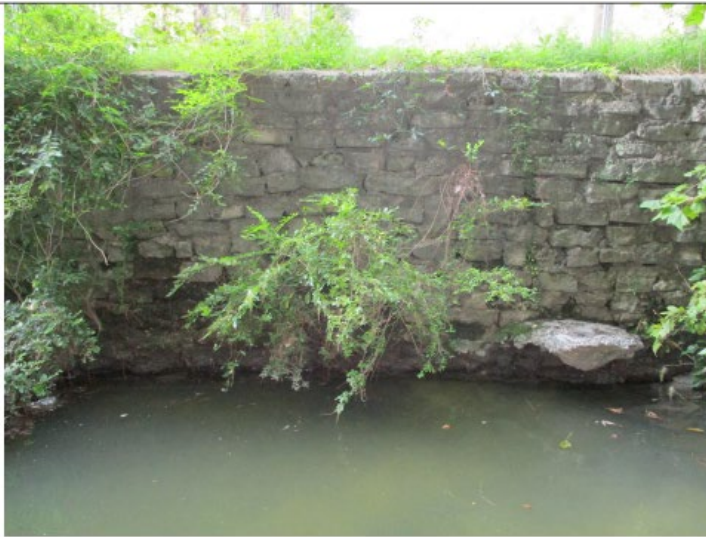
Photo No:  
4020D

Description:  
Undermining of wall  
for 20 ft.

Repair Priority: 2

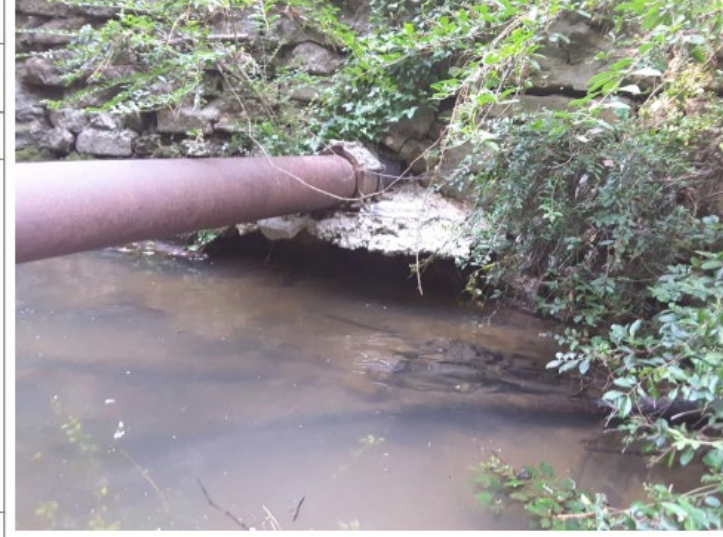
Photo No:  
4021B

Description:  
Exposed utility. Local  
undermining of pipe  
support.

Repair Priority: 2

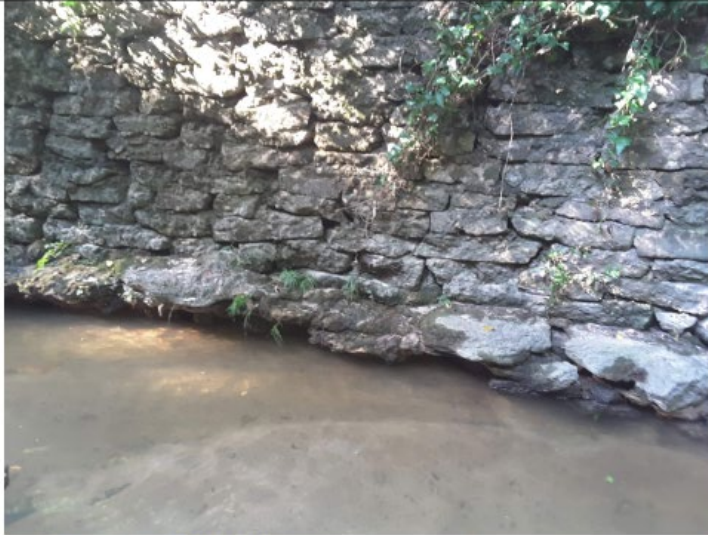
Photo No:  
4022A

Description:  
Undermining for 30 ft  
of wall.

Repair Priority: 2

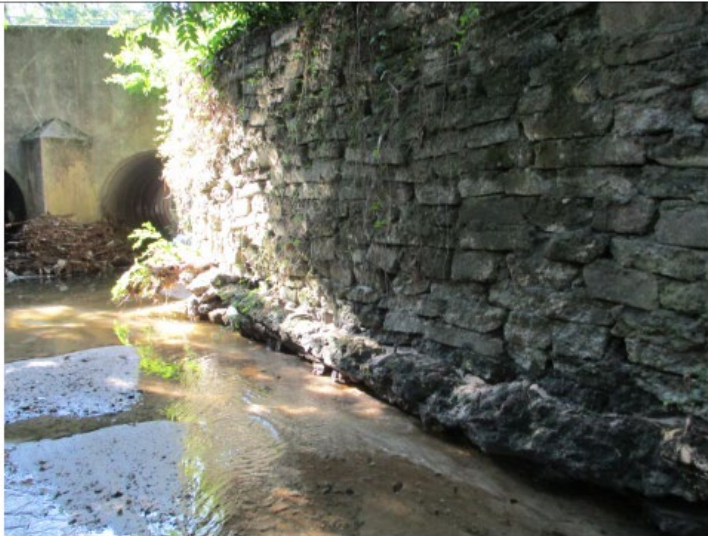
Photo No:  
4023D

Description:  
Undermining of 40 ft of  
wall.

Repair Priority: 2

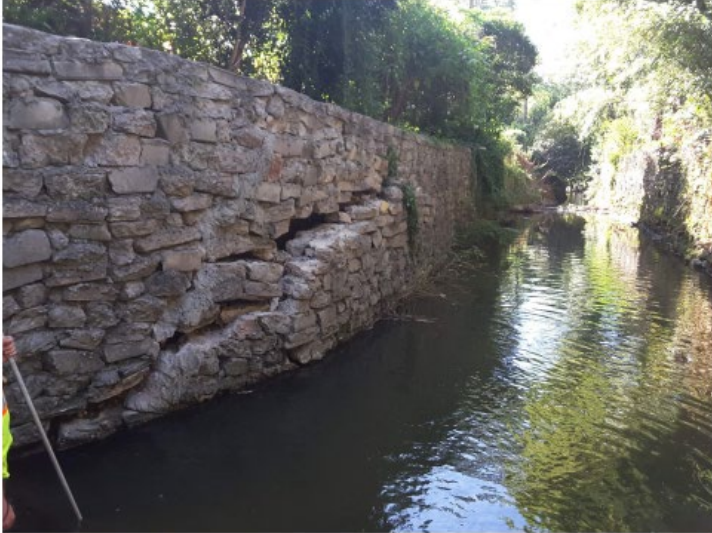
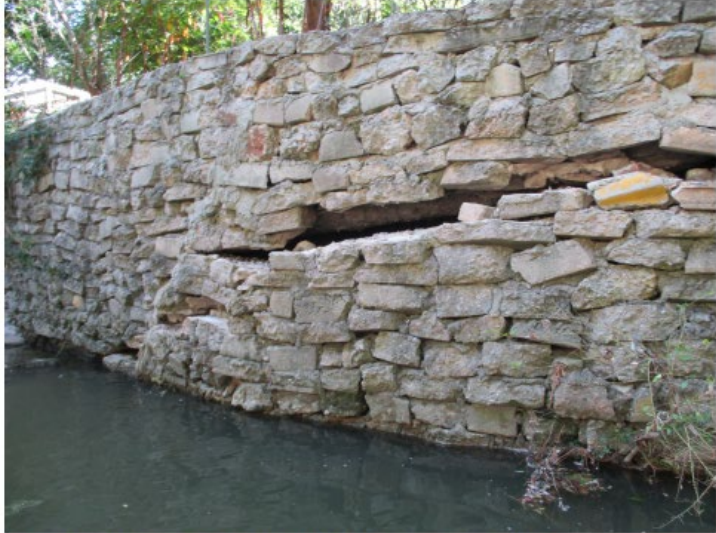
| <p>Photo No:<br/>4024A</p> <p>Location:<br/>Sta 32+30<br/>Left Wall</p> <p>Direction:<br/>Downstream</p> <p>Description:<br/>Wall failure.<br/>Undermining of wall<br/>for 100 ft downstream<br/>of concrete stream<br/>bottom protection</p> | | <p>Photo No:<br/>4024H</p> <p>Location:<br/>Sta 32+30<br/>Left Wall</p> <p>Direction:<br/>Upstream</p> <p>Description:<br/>Wall failure.<br/>Undermining of wall<br/>for 100 ft downstream<br/>of concrete stream<br/>bottom protection</p> | |
| <p>Repair Priority: 1</p> | | <p>Repair Priority: 1</p> | |

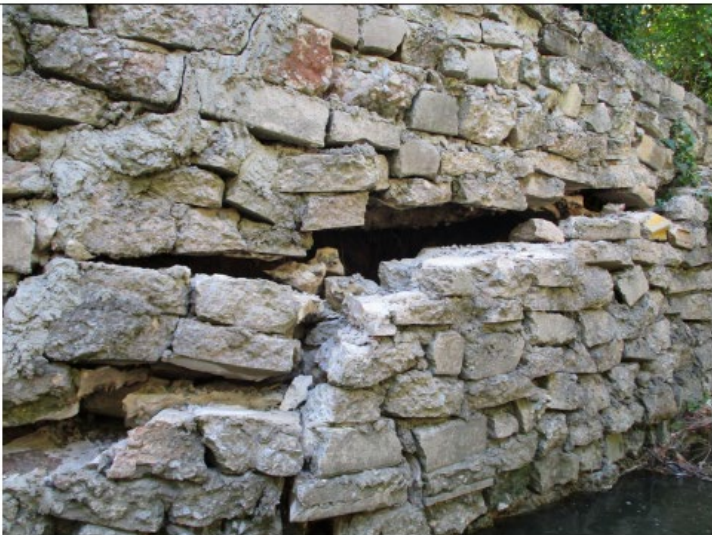
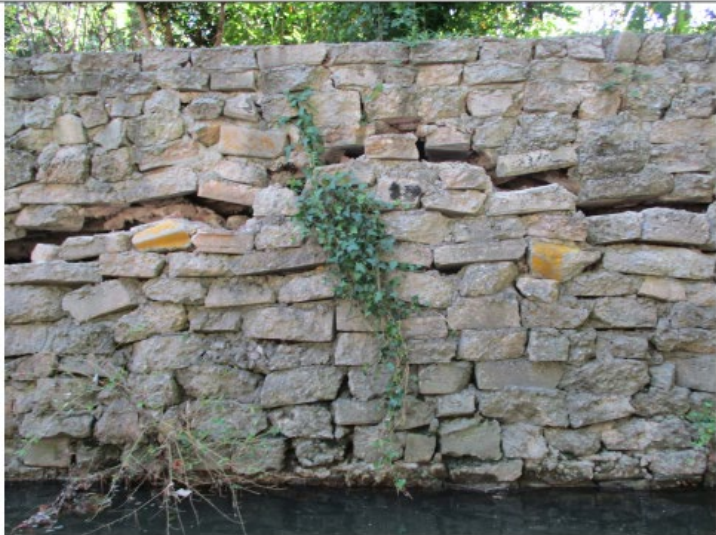
| <p>Photo No:<br/>4024D</p> <p>Location:<br/>Sta 32+30<br/>Left Wall</p> <p>Direction:<br/>Downstream</p> <p>Description:<br/>Wall failure.<br/>Undermining of wall<br/>for 100 ft downstream<br/>of concrete stream<br/>bottom protection.</p> | | <p>Photo No:<br/>4024I</p> <p>Location:<br/>Sta 32+30<br/>Left Wall</p> <p>Direction:<br/>Upstream</p> <p>Description:<br/>Wall failure.<br/>Undermining of wall<br/>for 100 ft downstream<br/>of concrete stream<br/>bottom protection</p> | |
| <p>Repair Priority: 1</p> | | <p>Repair Priority: 1</p> | |

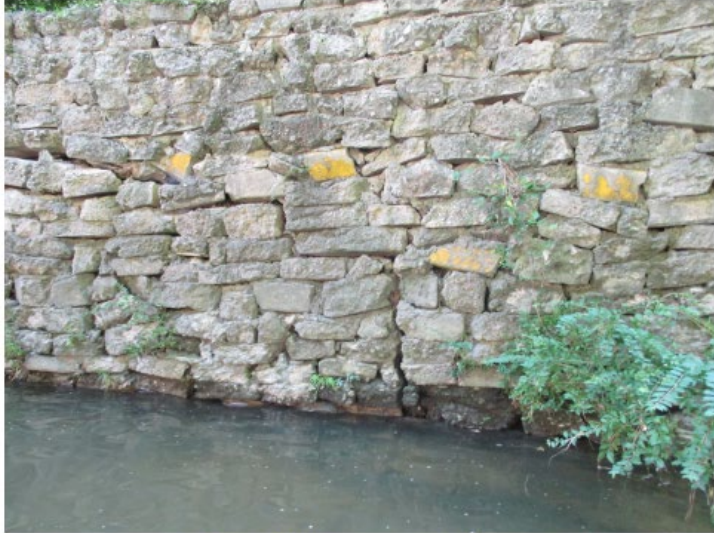
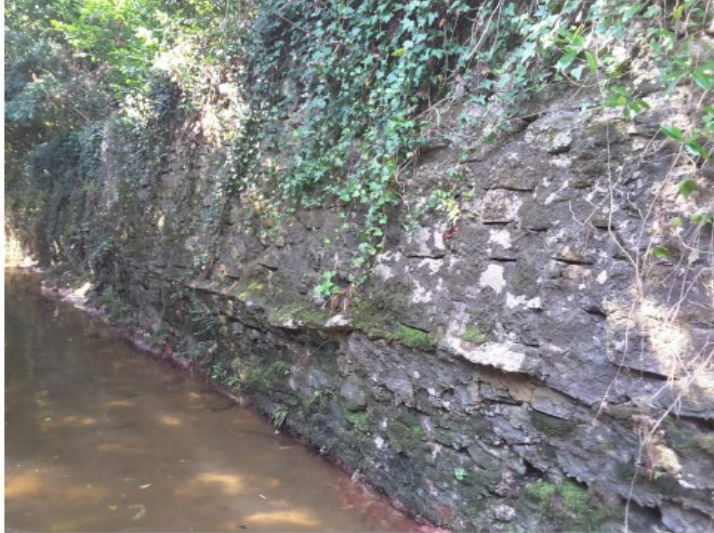
| <p>Photo No:<br/>4024J</p> <p>Location:<br/>Sta 32+30<br/>Left Wall</p> <p>Direction:<br/>Upstream</p> <p>Description:<br/>Wall failure.<br/>Undermining of wall<br/>for 100 ft downstream<br/>of concrete stream<br/>bottom protection</p> | | <p>Photo No:<br/>4027A</p> <p>Location:<br/>Sta 34+00<br/>Right Wall</p> <p>Direction:<br/>Downstream</p> <p>Description:<br/>Undermining of 30 ft of<br/>wall both sides after<br/>check dam.</p> | |
| <p>Repair Priority: 1</p> | | <p>Repair Priority: 2</p> | |

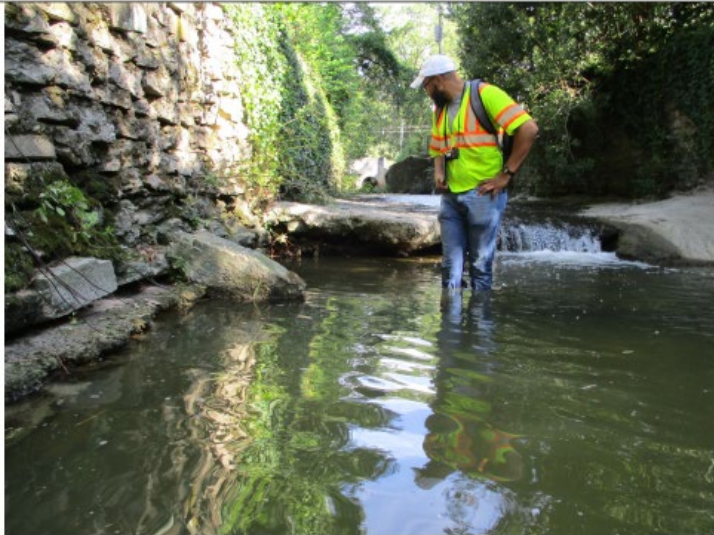
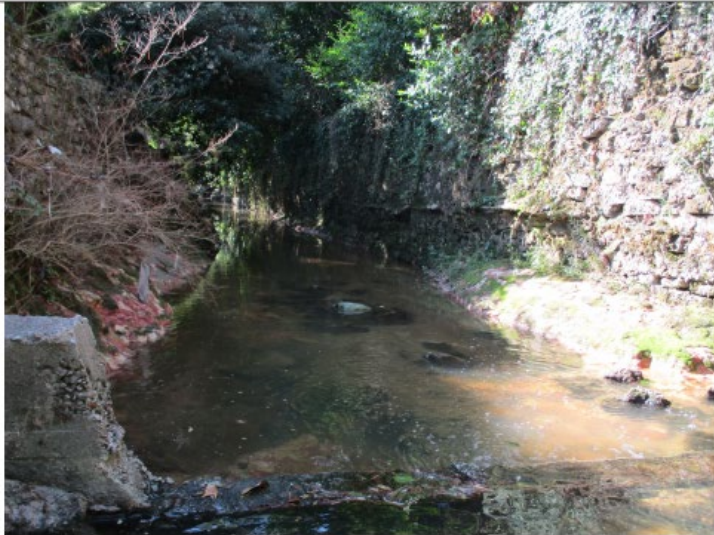
| <p>Photo No:<br/>4025D</p> <p>Location:<br/>Sta 32+35<br/>Right Wall</p> <p>Direction:<br/>Upstream</p> <p>Description:<br/>Undermining of wall<br/>for 100 ft downstream<br/>of concrete stream<br/>bottom protection.</p> | | <p>Photo No: 4027B</p> <p>Location:<br/>Sta 34+00<br/>Both Walls</p> <p>Direction:<br/>Downstream</p> <p>Description:<br/>Undermining of 30 ft of<br/>wall both sides after<br/>check dam.</p> | |
| <p>Repair Priority: 2</p> | | <p>Repair Priority: 2</p> | |

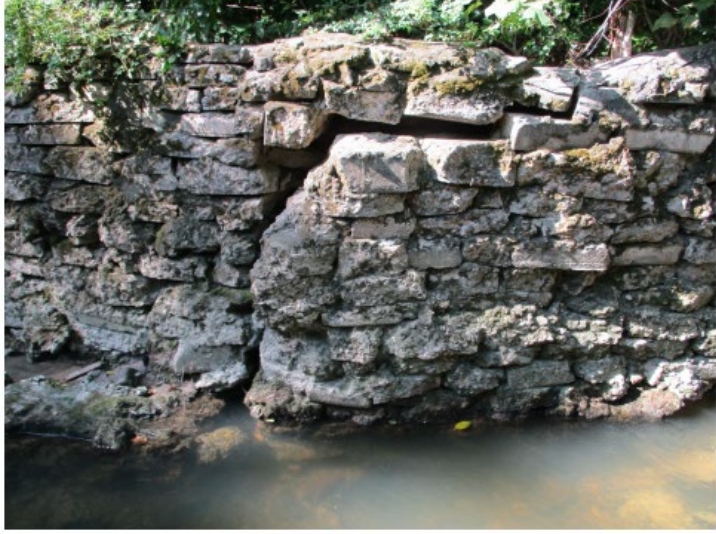
| Description:<br>Wall failure along 10ft.<br>of wall. Large crack in<br>wall for full height with<br>undermining for 20 ft<br>of wall. | |
| Repair Priority: 1 | |

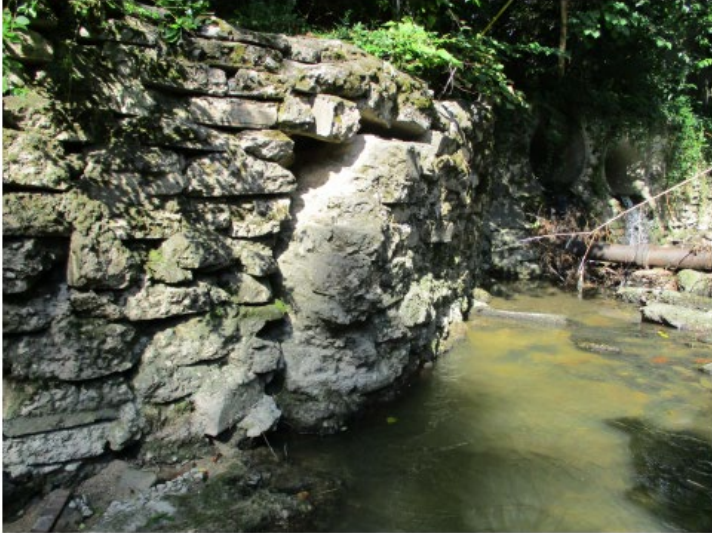
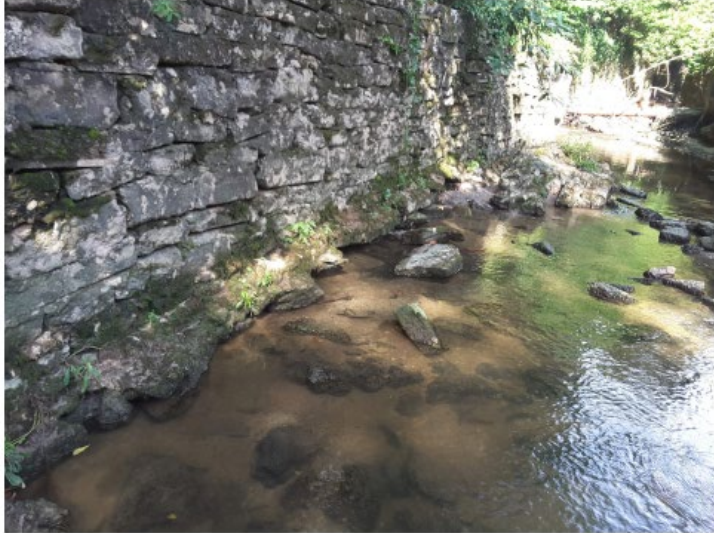
| <p>Photo No:<br/>4029D</p> <p>Location:<br/>Sta 37+00<br/>Right Wall</p> <p>Direction:<br/>Upstream</p> <p>Description:<br/>Wall failure along 10ft. of wall. Large crack in wall for full height with undermining for 20 ft of wall.</p> | | <p>Photo No:<br/>4031B</p> <p>Location:<br/>Sta 37+50<br/>Right Wall</p> <p>Direction:<br/>Upstream</p> <p>Description:<br/>Undermining for 40 ft of wall.</p> | |
| <p>Repair Priority: 1</p> | | <p>Repair Priority: 2</p> | |

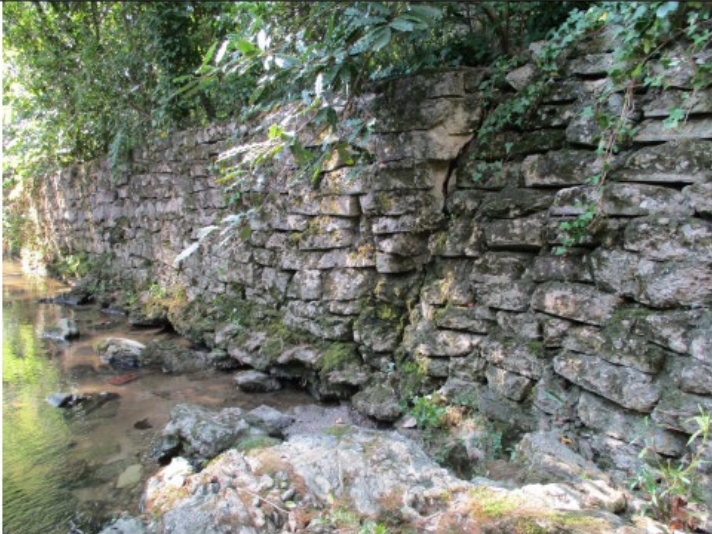
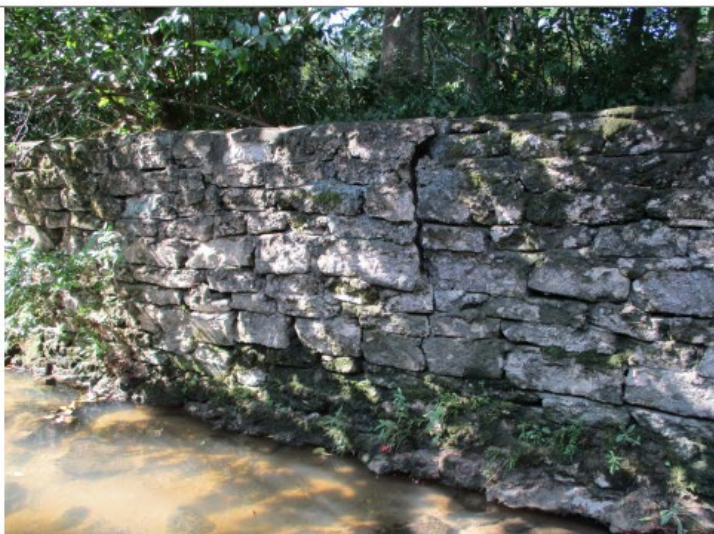
| <p>Photo No:<br/>4030C</p> <p>Location:<br/>Sta 37+20<br/>Right Wall</p> <p>Direction:</p> <p>Description:<br/>Large crack in wall for full height with undermining for 20 ft of wall.</p> | | <p>Photo No:<br/>4031E</p> <p>Location:<br/>Sta 37+50<br/>Right Wall</p> <p>Direction:<br/>Downstream</p> <p>Description:<br/>Undermining for 40 ft of wall.</p> | |
| <p>Repair Priority: 2</p> | | <p>Repair Priority: 2</p> | |

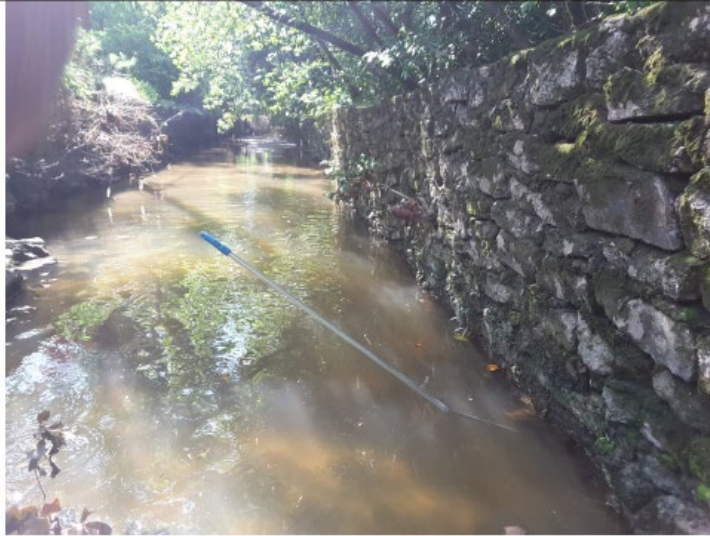
Photo No:  
4032A

Description:  
Undermining for 30 ft  
of wall.

Repair Priority: 2

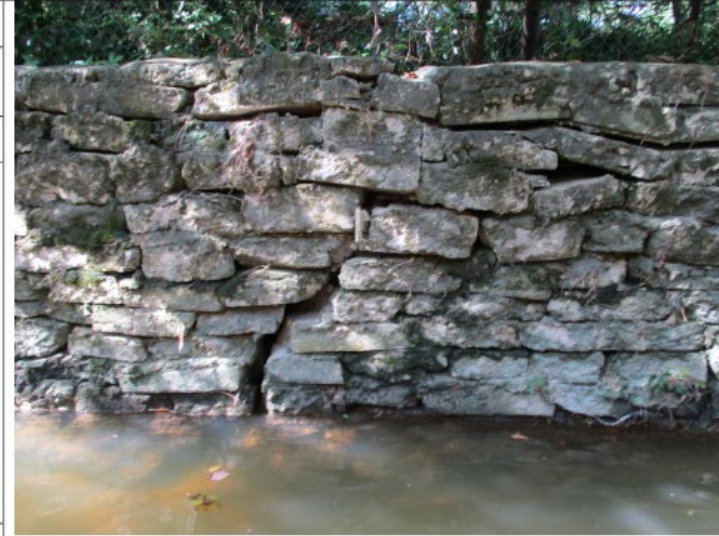
Photo No:  
4032G

Description:  
Large crack for full  
height of wall.  
Undermining for 30 ft  
of wall.

Repair Priority: 2

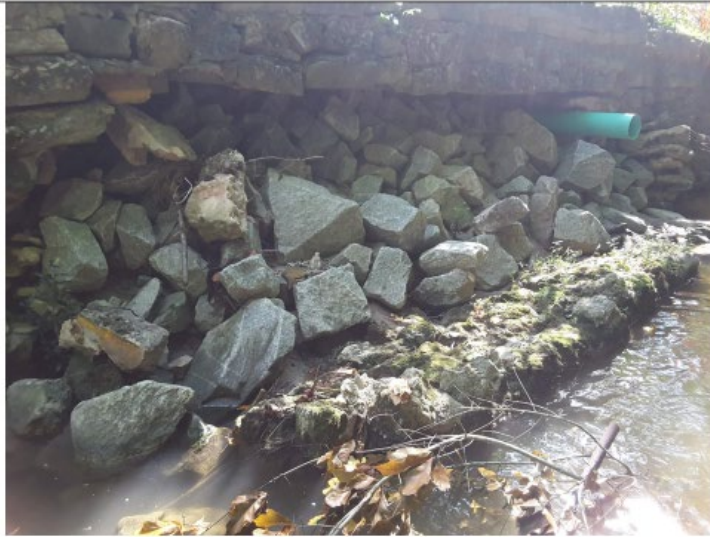
Photo No:  
4032B

Description:  
Wall failure for 20ft.  
Riprap placed to  
stabilize bank.

Repair Priority: 1

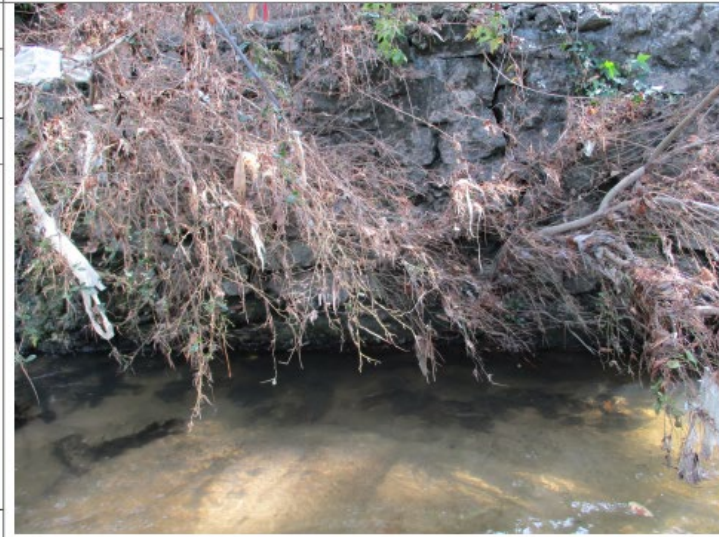
Photo No:  
4033A

Description:  
Large crack for full  
height of wall.  
Undermining for 70 ft  
of wall.

Repair Priority: 2

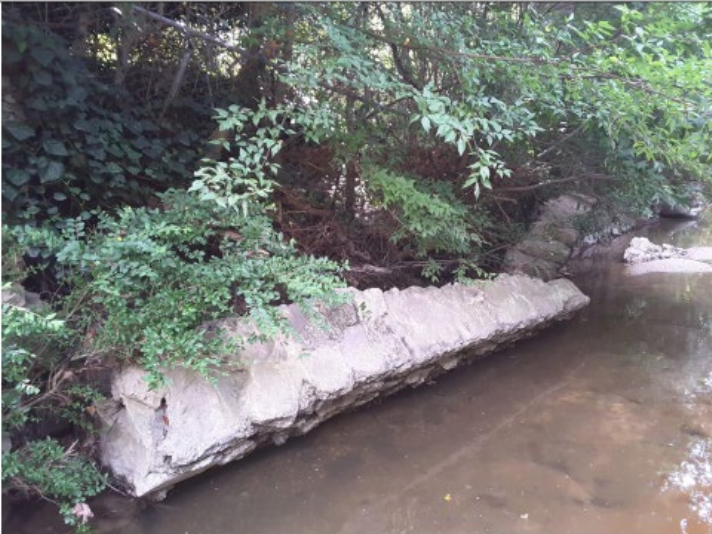
| Photo No:<br>4035A | |

| Description:<br>Wall failure for 50 ft. | |
| Repair Priority: 1 | |

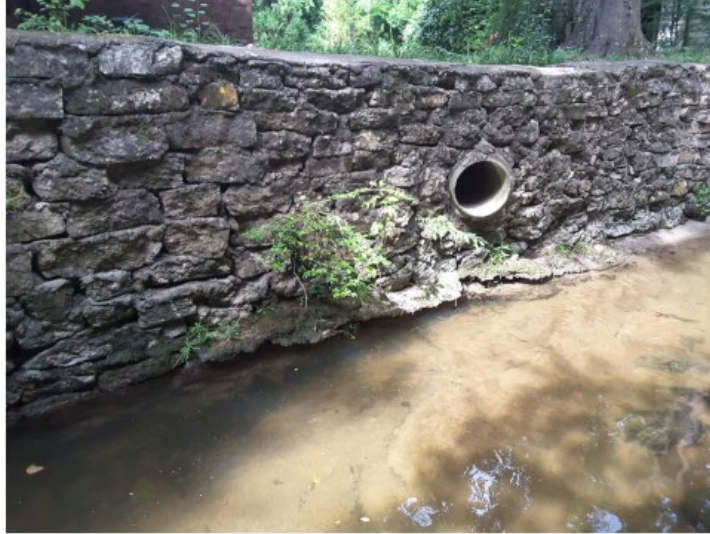
Photo No: 4036A

Location:  
Sta 46+75  
Right Wall  
Direction:  
Upstream  
Description:  
Undermining for 20 ft  
of wall.

Repair Priority: 2

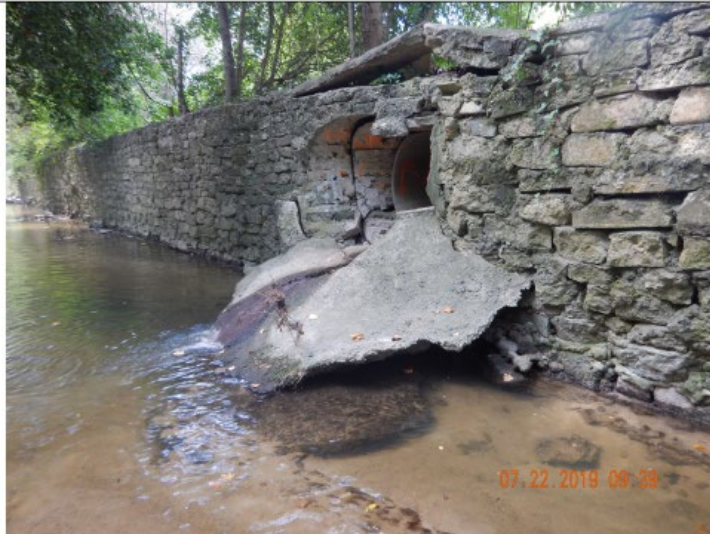
Photo No: 4037D

Location:  
Sta 47+30  
Right Wall  
Direction:  
Downstream  
Description:  
Undermining of  
stormwater apron. Wall  
Failure above pipe.

Repair Priority: 1

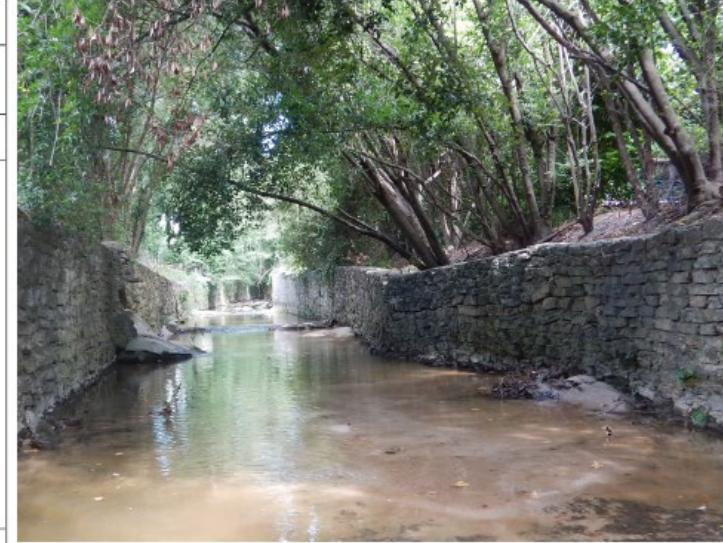
Photo No:  
4037F

Location:  
Sta 47+30  
Left Wall  
Direction:  
Upstream  
Description:  
Wall Bulging over 20  
ft. Soil behind wall  
subsiding. Trees  
leaning over wall.

Repair Priority: 2

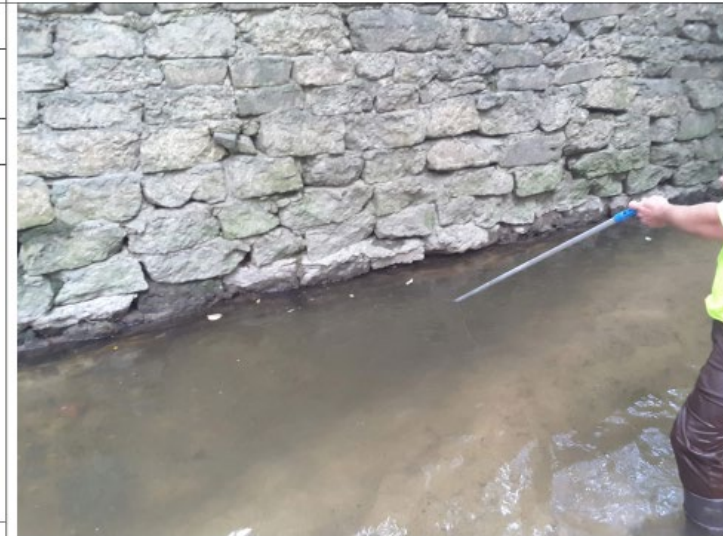
Photo No:  
4038A

Location:  
Sta 47+50  
Left Wall  
Direction:  
Downstream  
Description:  
Undermining of 15 ft  
of wall.

Repair Priority: 2

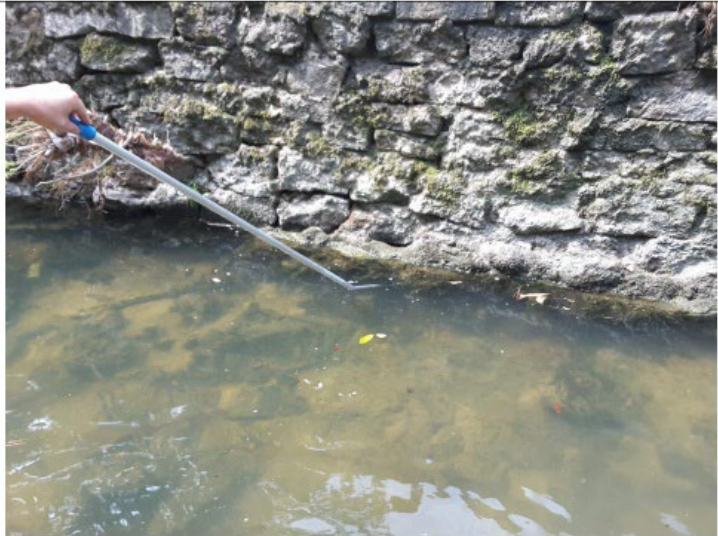
| Photo No:<br>4041A | |

| Description:<br>Undermining of 30 ft of<br>wall. | |
| Repair Priority: 2 | |

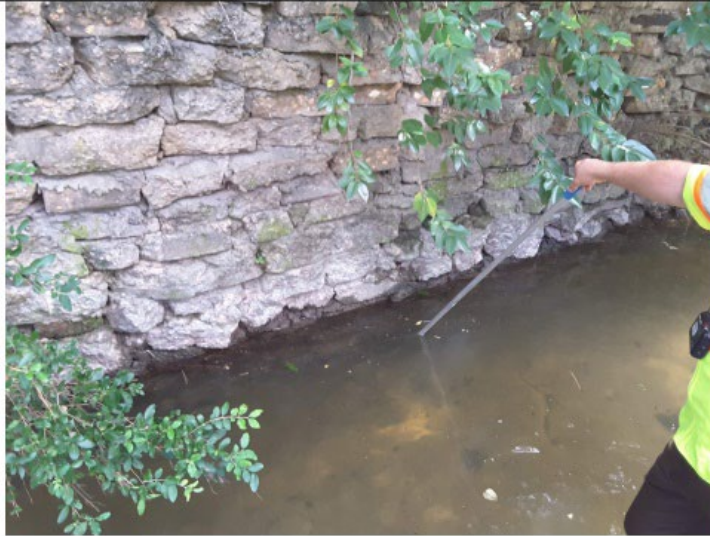
Photo No:  
4042A  
Location:  
Sta 54+15  
Right Wall  
Direction:  
Upstream  
Description:  
Undermining for 40 ft  
of wall.

Repair Priority: 2

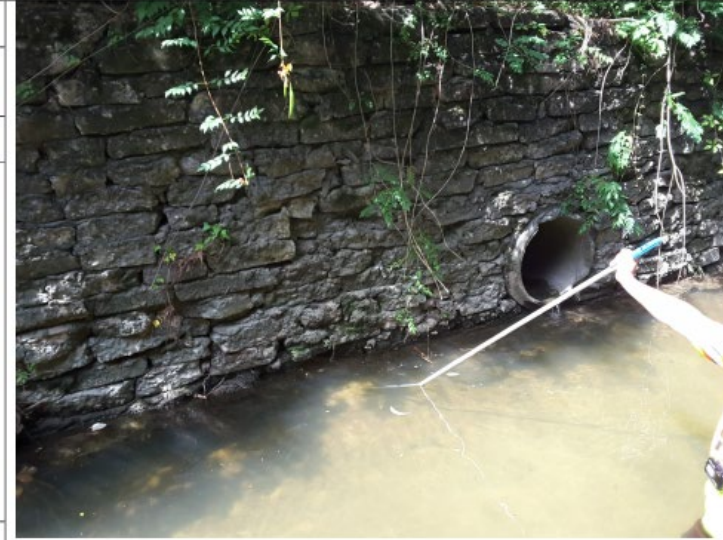
Photo No:  
4043A  
Location:  
Sta 54+60  
Right Wall  
Direction:  
Upstream  
Description:  
Undermining for 30 ft  
of wall.

Repair Priority: 2

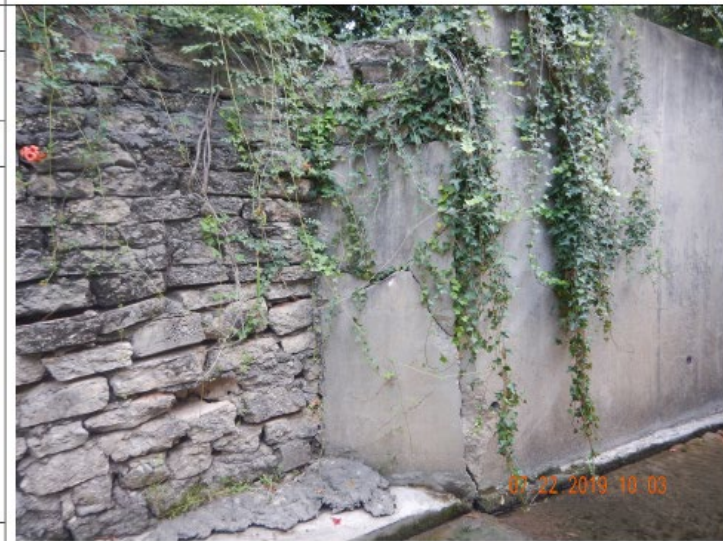
Photo No:  
4044D  
Location:  
Sta 55+15  
Left Wall  
Direction:  
Downstream  
Description:  
Cracks in culvert  
headwall upstream  
from Trenholm Rd  
Culvert.

Repair Priority: 3

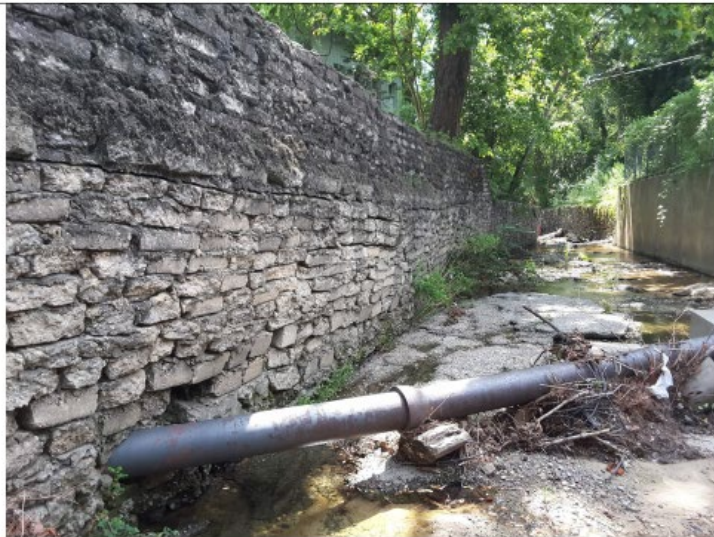
Photo No:  
4045A  
Location:  
Sta 57+50  
Left Wall

Description:  
Bulging wall for 110 ft  
of wall downstream of  
Trenholm Rd. culvert.  
Wall appears to have  
been add to in height at  
location of crack/bulge.

Repair Priority: 1

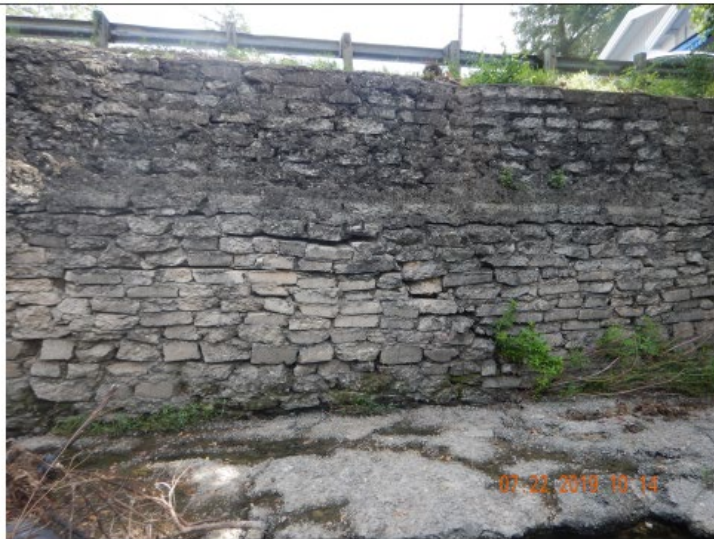
Photo No:  
4045G

Description:  
Bulging wall for 110 ft  
of wall downstream of  
Trenholm Rd. culvert.  
Wall appears to have  
been add to in height at  
location of crack/bulge.

Repair Priority: 1

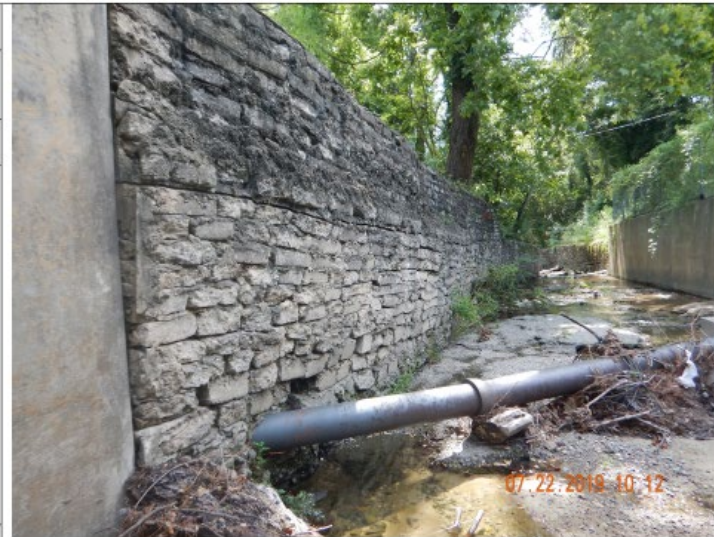
Photo No:  
4045D

Description:  
Exposed utility with  
erosion around pipe  
where it projects  
through the wall.

Repair Priority: 2

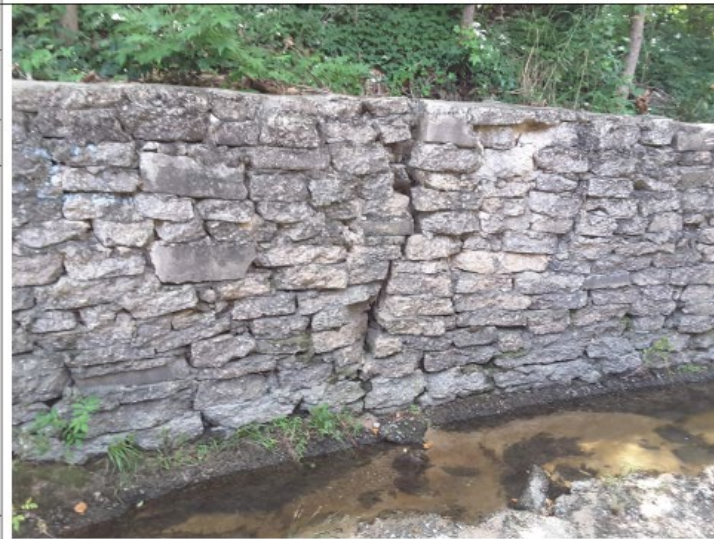
Photo No:  
4045B

Description:  
Crack for full height of  
wall.

Repair Priority: 2
