# A Case Study for Filbin Creek: Dispelling Rumors in the Floodplain

South Carolina Association for Hazard Mitigation Conference March 2020

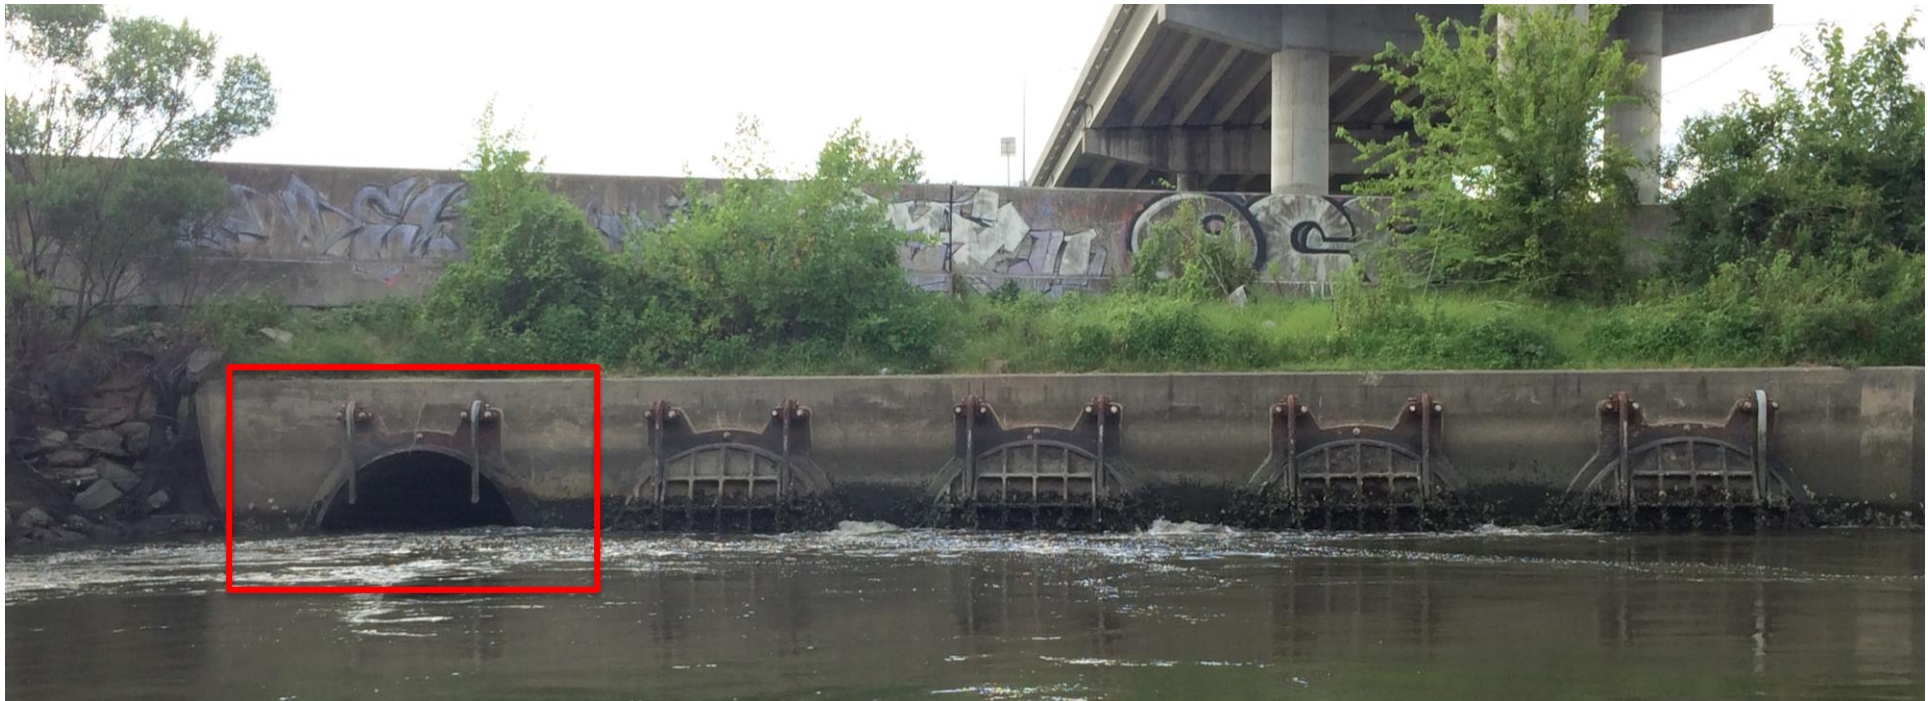
- Field reconnaissance
  - Identify any maintenance issues
    - Virginia Avenue (Remember the Flap Gates?)

- What's wrong with this picture?

- Locations identified for possible improvement
  - Virginia Avenue Culverts
    - Replace broken flap gate
    - Double the number of 84" culverts from 5 to 10
  - Norfolk & Southern Railroad Culverts
    - Replace the three 7' x 3.5' box culverts with a 60' trestle
    - (The original 54' trestle was replaced with the current culverts)
- Channel downstream of Attaway Street
  - Remove debris and obstructions to improve capacity

- Improvement Recommendation
  - Replacement of the missing flap gate at Virginia Avenue
