# **Penn Branch Improvement Project**

## ***An Ultra Urban Stream Stabilization Project***

# The Ugly: Masonry Wall Assessment

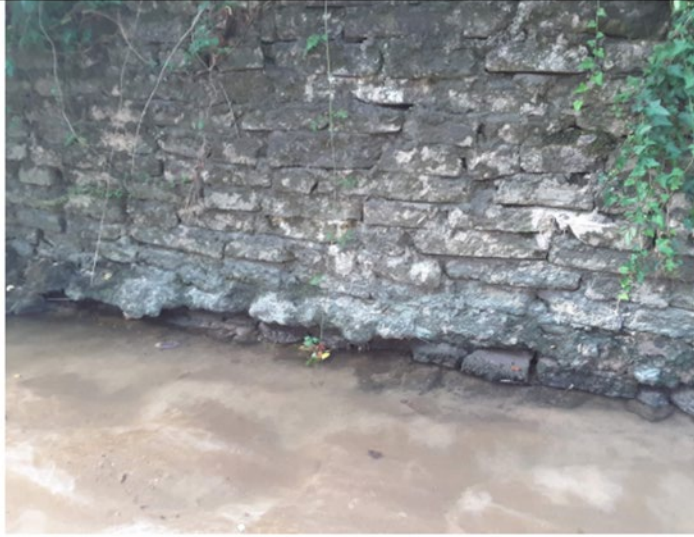
Photo No:  
4015A  
Location:  
Sta 21+10  
Right Wall  
Direction:  
Downstream  
Description:  
Undermining of 60 ft of  
wall.

Repair Priority: 2

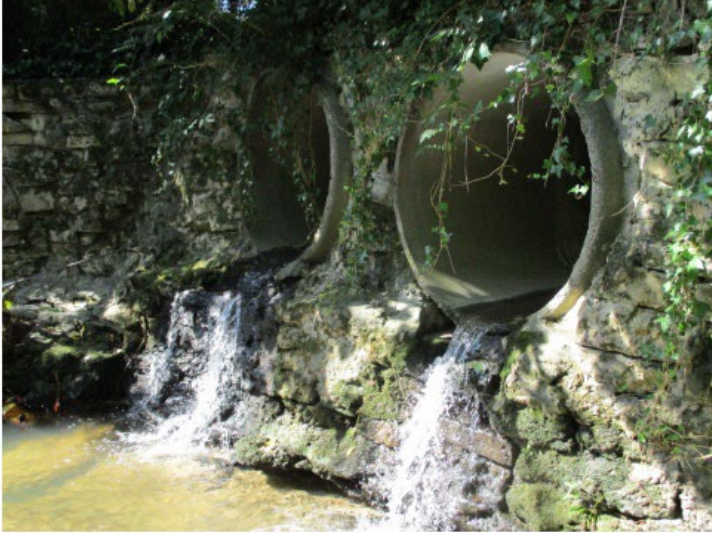
| Photo No:<br>3614E | | Photo No:<br>3614B | |
| Location:<br>Sta 36+75<br>Right Wall | | Location:<br>Sta 36+75<br>Both Walls | |
| Description:<br>Undermining of 10 ft of<br>wall below stormwater<br>outfall.. | | Description:<br>Exposed utility with<br>debris build-up. | |
| Repair Priority: 2 | | Repair Priority: 3 | |

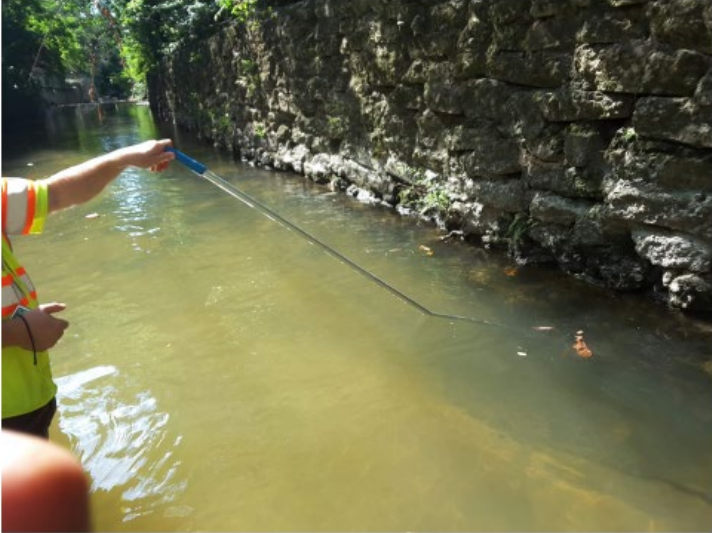
| Photo No:<br>4034A | |

| Location:<br>Sta 41+75<br>Right Wall | |
| Repair Priority: 2 | |

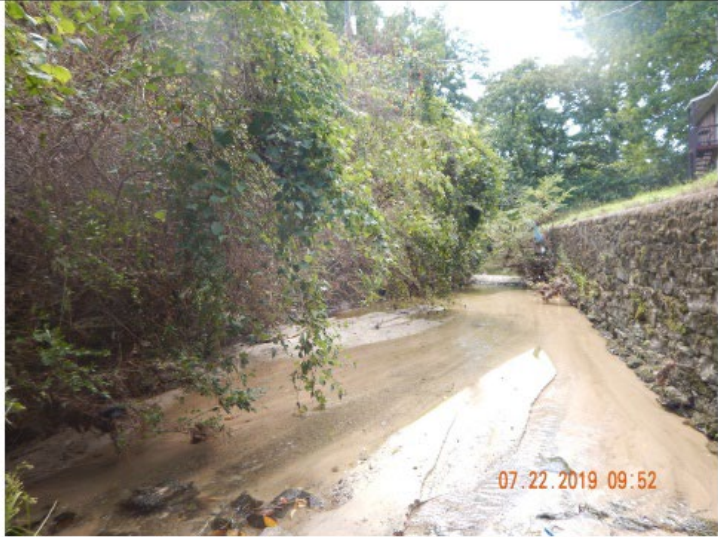
| Photo No:<br>4040C | |

| Location:<br>Sta 51+00<br>Left Wall | |
| Repair Priority: 3 | |
